Auditee :	<b>Shenzhen Vstarcam Technology Co., Ltd.</b>
Audit Date From :	<b>25/02/2019</b>
Audit Date To :	<b>27/02/2019</b>
Expiry Date of the Audit :	<b>Please refer to the producer profile in the amfori BSCI platform</b>
Auditing Company :	<b>TUEV Rheinland</b>
Auditor's Name(s) :	<b>Sam Li(Lead)</b>
Auditing Branch (if applicable) :	<b>TUV Rheinland China</b>

Name of producer :	Shenzhen Vstarcam Technology Co., Ltd.		
DBID number :	364932		
Audit ID :	144230		
Address :	4-5th Floor, G Building, Jiangxia Tech Park, Shengping Road, Huangfengling Industrial Zone, Luoazu Community, Shiyan Street, Baoan District, Shenzhen		
Province :	Guangdong	Country :	China
Management Representative :	Yan Lin/ Sales Manager		
Contact person:	Yan Lin	Sector :	Non-Food
Industry Type :	Media and graphical industry	Product group :	Audio, Visual and photography
Product Type :	IP Camera, Smart home, Dash cam

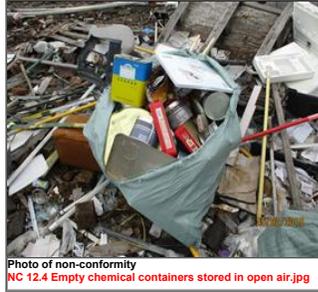
Photo of non-conformity  
NC 12.4 Empty chemical containers stored in open air.jpg

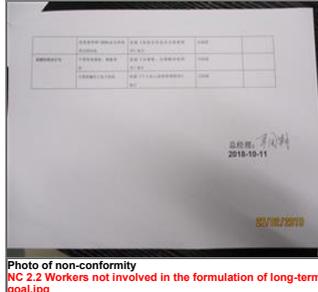
- 2.2 - The factory provided the long-term goal of protecting workers. However, according to interviews with workers and worker representatives and documentation, workers and worker representatives were not involved in the formulation of long-term protection goals.  
工厂提供了保护工人的长期目标。但是,根据员工和员工代表访谈以及文件记录,员工及员工代表并没有参与到长期保护目标的制订。

Photo of non-conformity  
NC 2.2 Workers not involved in the formulation of long-term goal.jpg

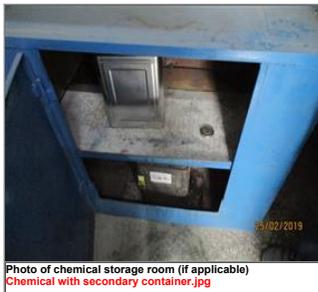
Photo of chemical storage room (if applicable)  
Chemical with secondary container.jpg

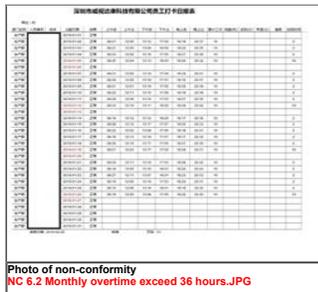
6.2 - As per the reviewed time records from February 2018 to February 27, 2019. There was no obvious and peak season in the facility. 20 sampled employees' time records were selected in March 2018, November 2018 and January 2019 respectively. The samples and the detailed overtime hours were as below: All 20 sampled employees' monthly overtime hours in March 2018 were exceed 36 hours, which up to 94 hours. All of 20 sampled employees' monthly overtime hours in November 2018 were exceed 36 hours, which up to 84 hours. All 20 sampled employees' monthly overtime hours in January 2019 were exceed 36 hours, which up to 76 hours. Managers said that the factory did not establish the pre-warning system for working hours, nor did they formulate the overtime management and control plan. Overtime was based on the principle of voluntariness, and workers also want to work more overtime to earn more money. Thus, workers conducted excessive monthly overtime systematically exceeding local law requirement in the reviewed months. As per workers statement, overtime work was voluntary and they could refuse to work overtime and no punish for the refuse of overtime. They did not know the upper limit of the overtime working. Remark: The maximum monthly overtime hours in February 2019 (till February 27, 2019) were up to 42 hours. Reference Law: PRC Labour law, Article 41. 根据2018年2月至2019年2月27日的考勤，工厂没有明显的淡旺季。2018年3月，2018年11月，2019年1月分别抽了20名员工，加班情况如下：2018年3月份所有20名抽样员工月加班超过36小时，最大为94小时，2018年11月份所有20名抽样员工月加班超过36小时，最大为84小时，2019年1月份所有20名抽样员工月加班超过36小时，最大为76小时。管理人员表示，工厂没有建立工时预警系统，也没有制定加班管控计划。加班基于自愿原则，工人也希望多进行加班获取更多收入。因此，员工在查看的月份都加班系统性超过法律要求。受访的工人称加班是自愿的，可以拒绝加班，没有因此受到惩罚。不清楚加班上限值。备注：2019年2月（至2019年2月27日）最大月加班小时为42小时；参考法律《中华人民共和国劳动法》第四十一条。

Photo of non-conformity  
NC 6.2 Monthly overtime exceed 36 hours.JPG

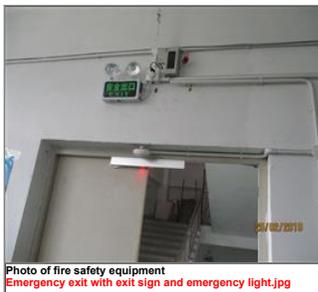
Photo of fire safety equipment  
Emergency exit with exit sign and emergency light.jpg

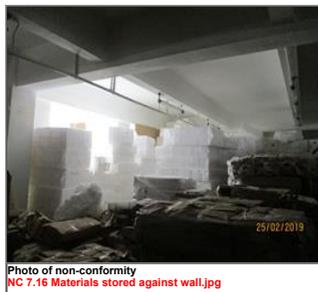
7.16 -	According to the on-site observation, the packing material goods and finished goods on 5F of building F were stored against to the wall. The distance between the walls was less than the legal requirements of 0.5 meters. Reference law: General rules for fire safety management of storage occupancies (GA 1131-2014), 6.8. 根据现场观察，工厂F栋五楼仓库存放的包材和成品均靠墙，与墙的距离小于法律规定的0.5米。参考法律：《仓储场所消防安全管理通则》(GA 1131-2014), 6.8。
<b>Remarks from Auditee:</b>	
<b>Performance Area 8 : No Child Labour</b>	
Full Audit [Audit Id - 144230] Audit Date: 25/02/2019 PA Score: A	Deadline date:
<b>GOOD PRACTICES:</b>	
<b>AREAS OF IMPROVEMENT:</b>	
<p>The auditee has formulated appropriate recruitment procedures. Each worker was required to provide the original identity card for check at the time of entry. When the recruiter has doubts about the age of the employee, he/she will verify the employee through skilled interviews. In addition, the auditee has also formulated remedial measures for child labour to prevent misrecruitment. During the audit process, no child labor was found by reviewing the personnel information of all employees, on-site inspection, worker and management interviews.</p> <p>被审核方制定了合适的招聘程序。每个工人在入职时均需要提供身份证原件以供审查。当招聘专员对员工的年龄有怀疑时，会通过有技巧地访谈以核实员工情况。此外，被审核方也制定了童工补救措施以防止误招童工。在审核过程中，通过查阅所有员工的人事资料，现场巡查，员工和管理访谈，未发现有任何童工存在。</p>

Photo of non-conformity  
NC 7.16 Materials stored against wall.jpg

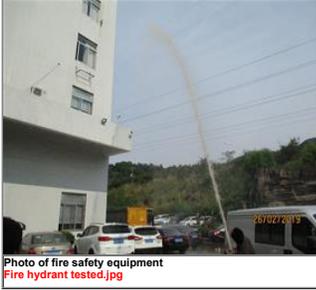
Photo of fire safety equipment  
Fire hydrant tested.jpg

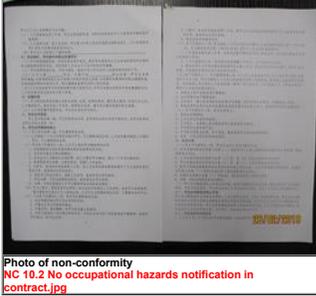
Full Audit [Audit Id - 144230] Audit Date: 25/02/2019 PA Score: A	Deadline date:24/05/2019
<b>GOOD PRACTICES:</b>	
<b>AREAS OF IMPROVEMENT:</b>	
<p>All workers were recruited directly by the factory. Workers will sign the labor contract with the factory on the day of entry, and they will keep one copy of the contract. The establishment of employment relationship did not cause insecurity of workers. There was no evidence to show the factory tried any unfair employment method to reduce its obligations. However, gaps were still noted in implementation.</p> <p>所有工人都是工厂直接招聘的。工人在入职当天会与工厂签订劳动合同，同时自己会保留一份合同副本。建立劳动关系不会给员工带来不安全地位。未有任何证据显示工厂有通过不公平的雇佣方式去减少其义务。但是，在实施过程中仍存在差距。</p> <p>10.2 - As per the labor contract review, employee and management interview, it was noted that no occupational hazards notification for relevant operators was in place, such as soldering and pad printing workers exposed to dust and chemicals. Reference Law: People's Republic of China on Prevention and Control of Occupational Diseases Article 33.</p> <p>根据工人劳动合同审核，员工和管理访谈发现，工厂没有对有害岗位进行职业危害告知，如焊锡和移印岗位员工接触烟尘和化学品。参考法律法规：中华人民共和国职业病防治法第三十三条。</p>

Photo of non-conformity  
NC 10.2 No occupational hazards notification in contract.jpg
